# Rehabilitation of Longitudinal Joints in Double-Tee Girder Bridges

REHABILITATION OF LONGITUDINAL JOINTS IN DOUBLE-TEE  
GIRDER BRIDGES

A thesis in partial fulfillment of the requirements for the

Major in Civil Engineering

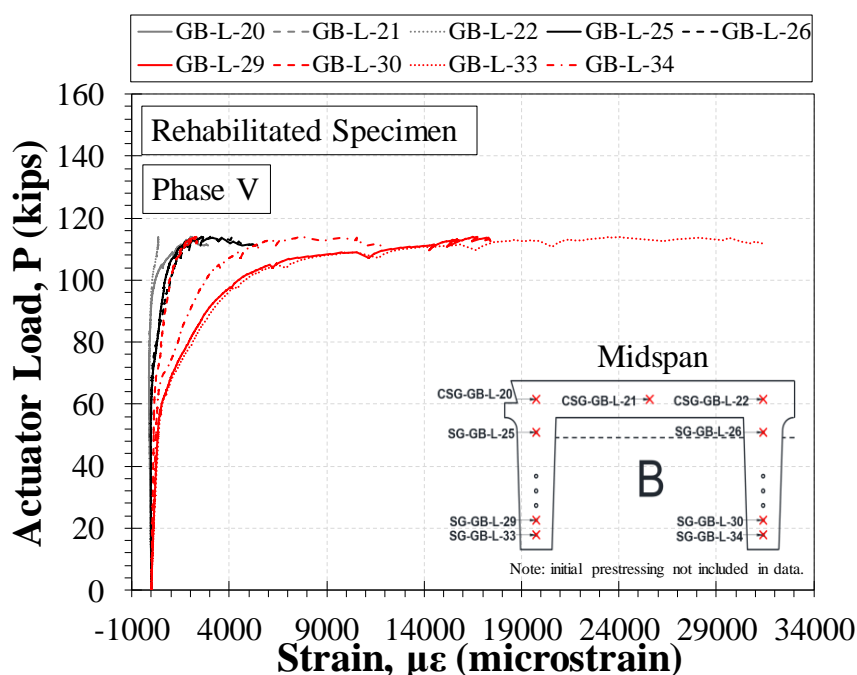
**Figure 7-26. Measured Strains of Girder B in Rehabilitated Double-Tee Bridge Specimen during Strength Testing**

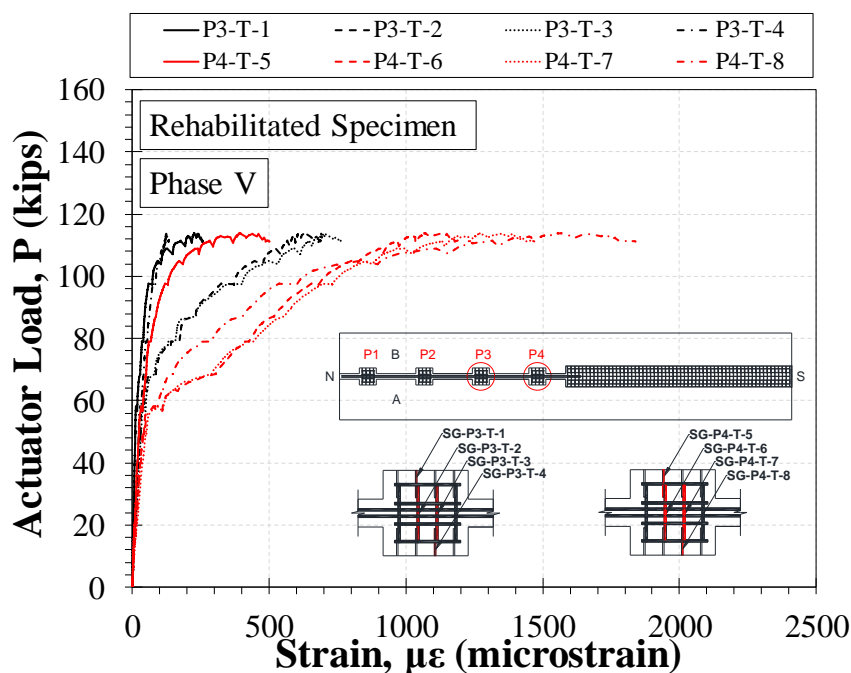
**Figure 7-27. Measured Strains of Transverse Reinforcement in UHPC Pockets of Rehabilitated Double-Tee Bridge Specimen during Strength Testing**

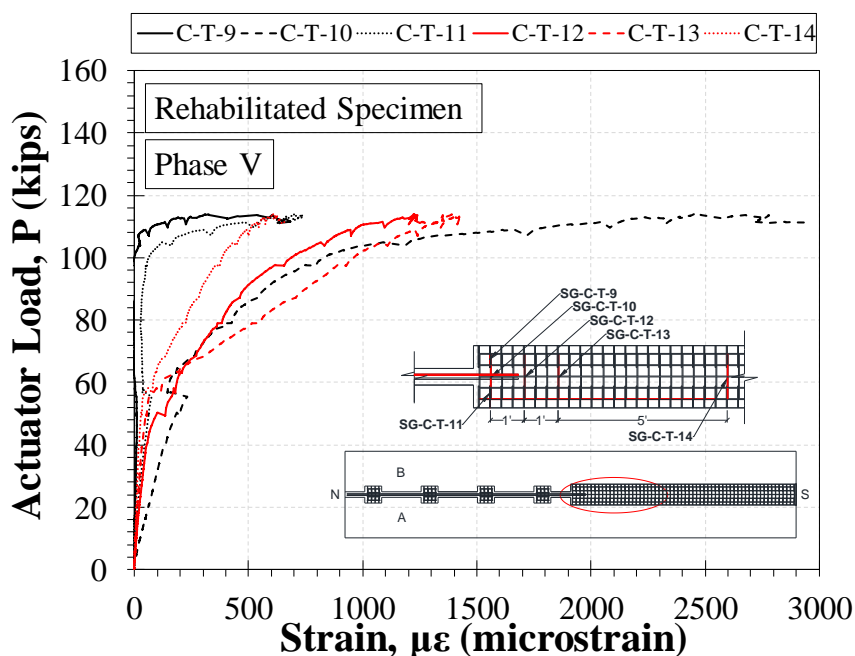
Figure 7-28. Measured Strains of Transverse Reinforcement in LMC Continuous Joint of Rehabilitated Double-Tee Bridge Specimen during Strength Testing

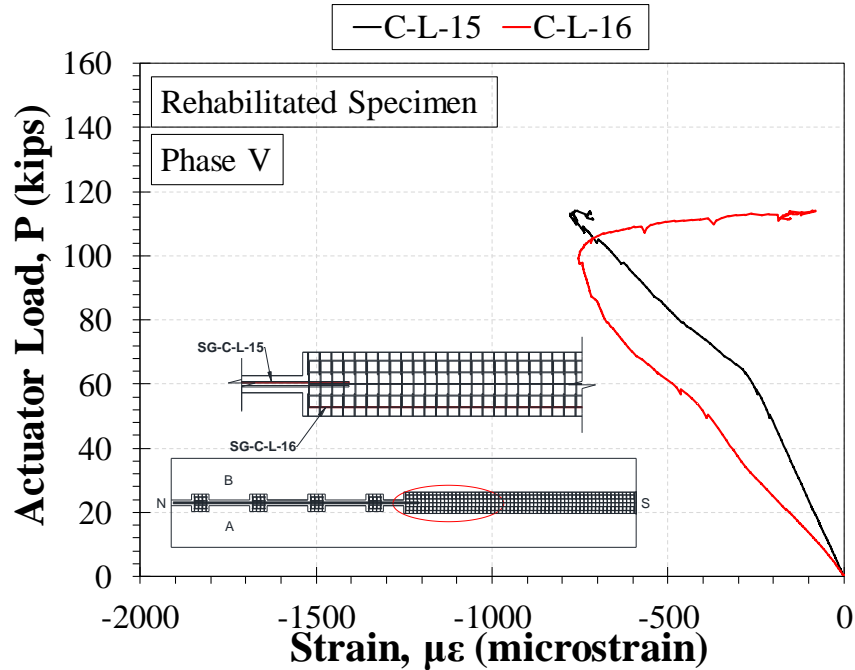
**Figure 7-29. Measured Strains of Joint Longitudinal Reinforcement in Rehabilitated Double-Tee Bridge Specimen during Strength Testing**

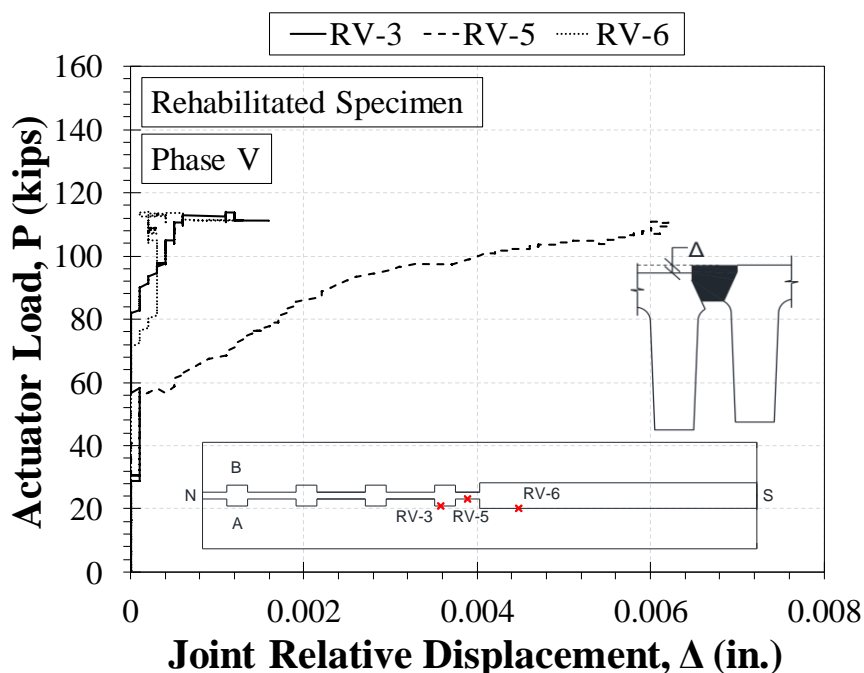
**Figure 7-30. Girder-to-Girder Joint Relative Displacement for Rehabilitated Double-Tee Bridge Specimen during Strength Testing**

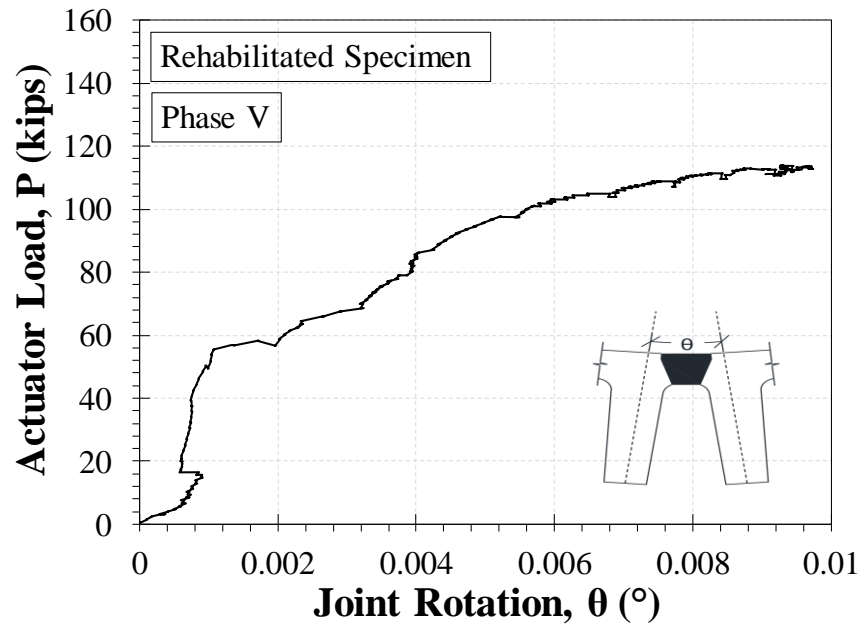
Figure 7-31. Girder-to-Girder Joint Rotation for Rehabilitated Double-Tee Bridge Specimen during Strength Testing

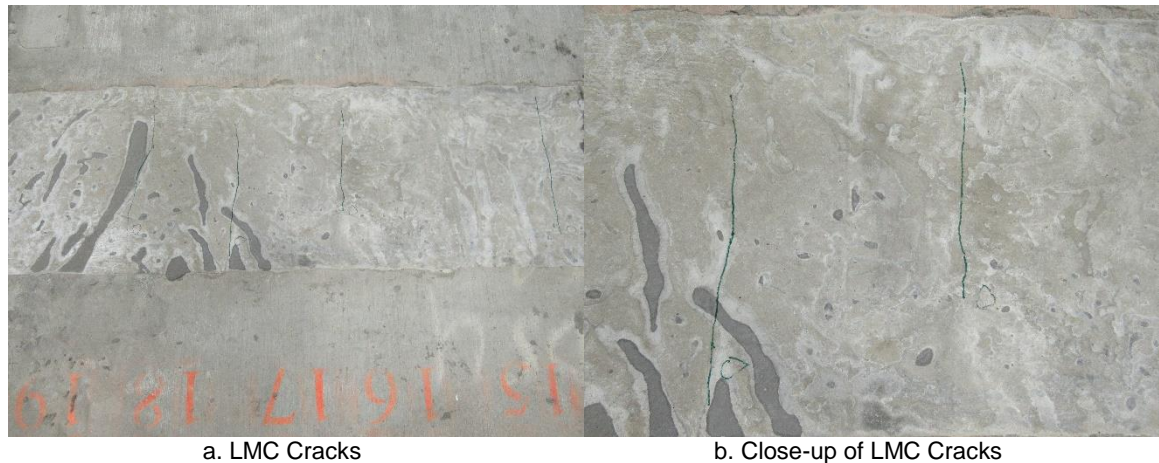
**Figure 8-1. Transverse Cracks of Continuous Joint in Rehabilitated Double-Tee Bridge**

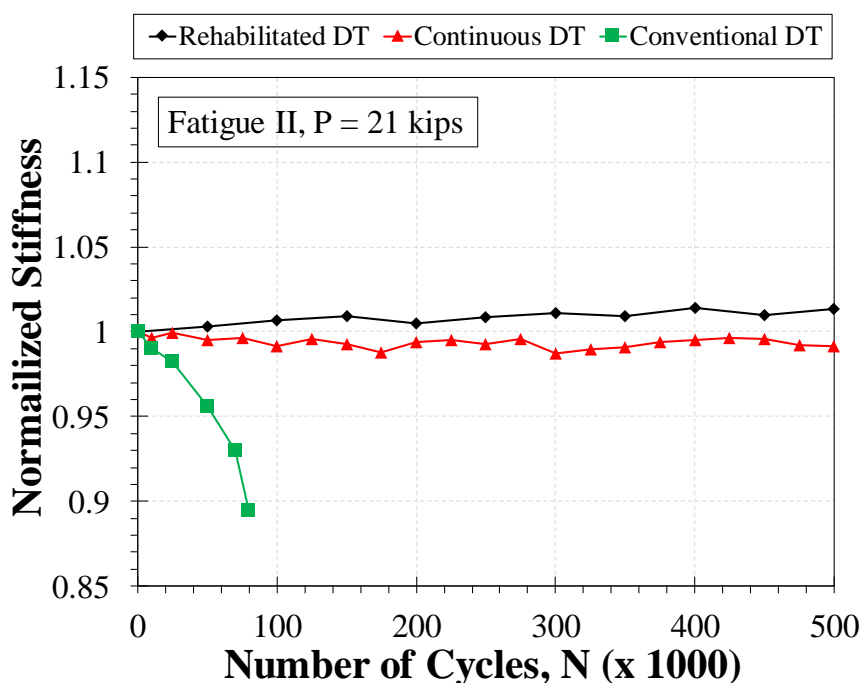
Figure 8-2. Stiffness Degradation for Different Double-Tee Bridges under AASHTO Fatigue II Loading

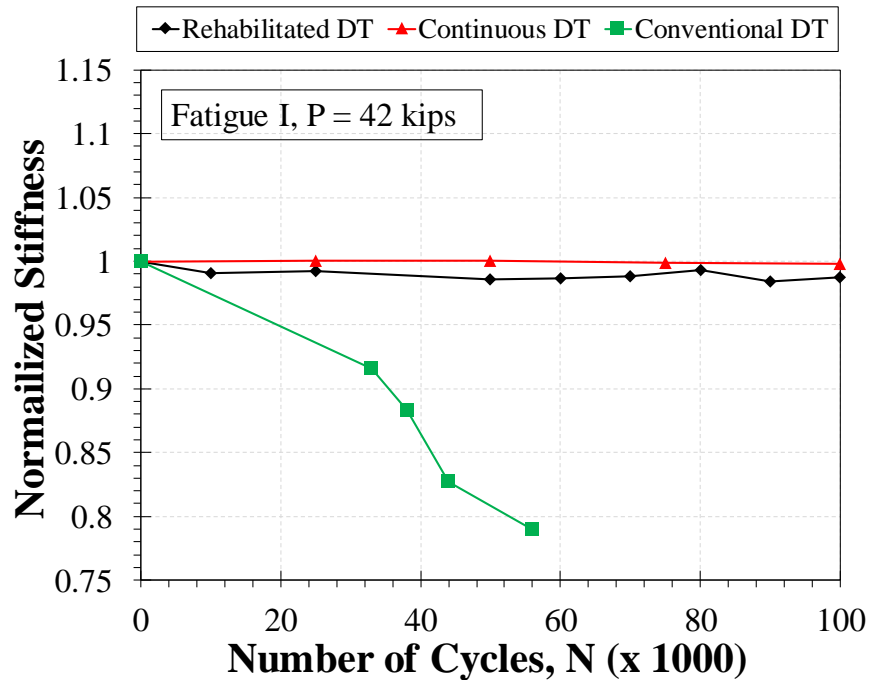
Figure 8-3. Stiffness Degradation for Different Double-Tee Bridges under AASHTO Fatigue I Loading

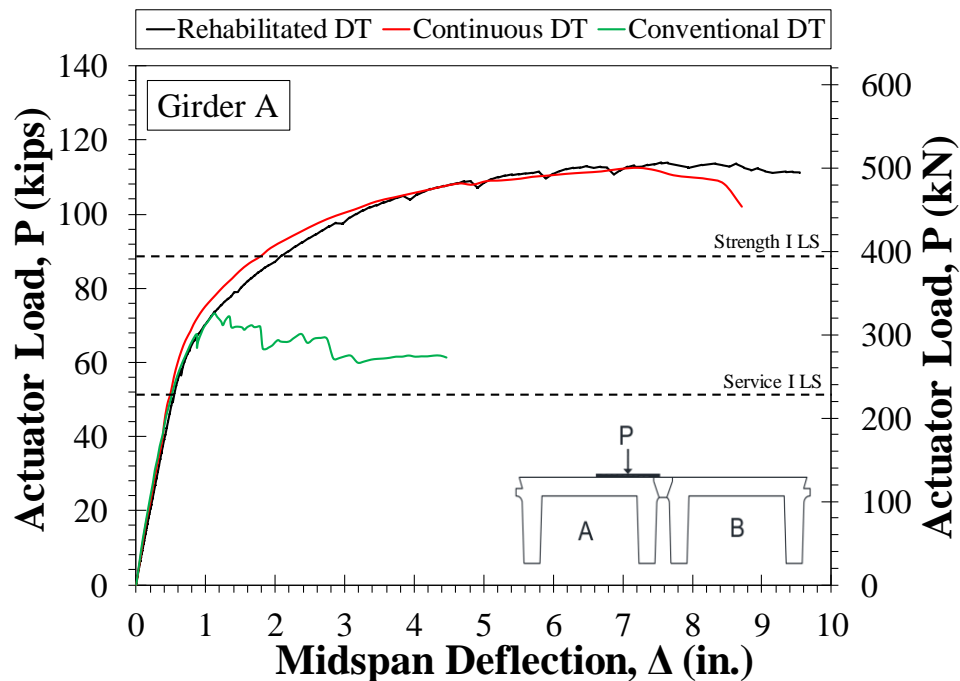
Figure 8-4. Force-Displacement Relationship for Loaded Girders of Different Double-Tee Bridges
